# A comparative evaluation of fracture load of monolithic and bilayered zirconia crowns with and without a cervical collar: an in vitro study

**Objective.** This study was performed with the objective to compare and evaluate the fracture load of monolithic and bilayered zirconia crowns with and without a cervical collar.

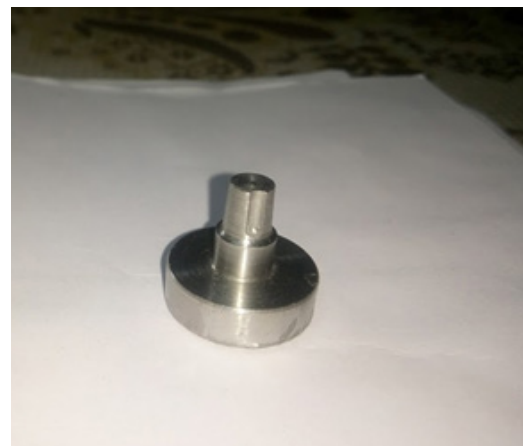
Figure 1. Custom made metal mold.

From a solid metal rod, one single 12 mm long cylindrical metal die with a 6° taper, shallow chamfer finish line, with an orientation groove extending 0.5 mm above the finish line and rounded internal angles was fabricated (Figure 1). From this single customized metal die 45 zirconia crowns (Koho), with a cement space of 30 microns, were produced by computerized and milling unit ((LAVA Scan ST; 3M ESPE). The crowns that were fabricated are as follows:

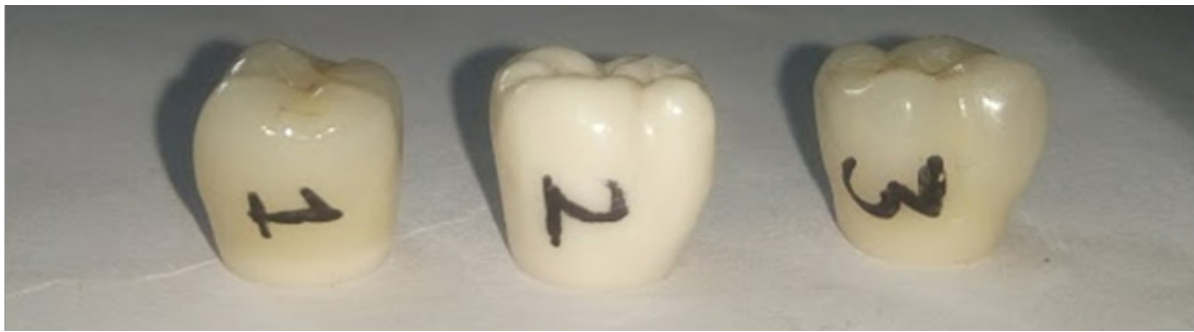
**Figure 2.** Zirconia crowns. Group 1: bilayered zirconia crowns with standard coping for core veneer crowns with additional 1 mm cervical zirconia collar. Group 2: monolithic anatomic contour crown. Group 3: bilayered zirconia crowns with standard coping for core veneer crowns.

Group 1: 15 bilayered zirconia crowns with standard coping for core veneer crowns with additional 1 mm cervical zirconia collar.

Group 2: 15 monolithic anatomic contour crowns.

Group 3: 15 bilayered zirconia crowns with standard coping for core veneer crowns.

The copings of the bilayered crowns were veneered using veneering ceramic (e.max, Ceram; Ivoclar Vivadent AG) (Figure 2). The marginal integrity of the fabricated crowns was evaluated both prior to and after cementation by confocal microscopy (Figure 3). The crowns were luted to the metal mould using Zinc phosphate cement (Pyrex, India). Excess cement was removed and crowns were stored in distilled water at room temperature for 24±2 hours. The crowns were subsequently loaded centrally at the occlusal surface with a steel ball 25 mm in diameter and were cushioned with a 3 mm ethylene propylene diene rubber disc to prevent any contact damage. The load was applied with a Universal Testing Machine with a crosshead speed of 1.08 mm/min till the fracture occurred. The assembly was placed in the water at room temperature during the flexure testing and the load at fracture was recorded (Figure 4).

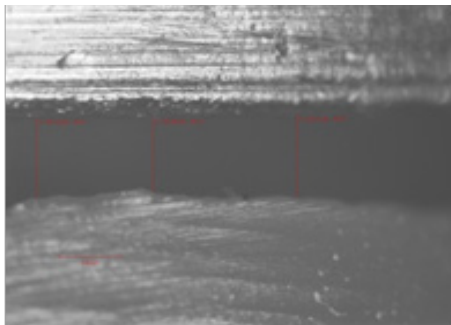
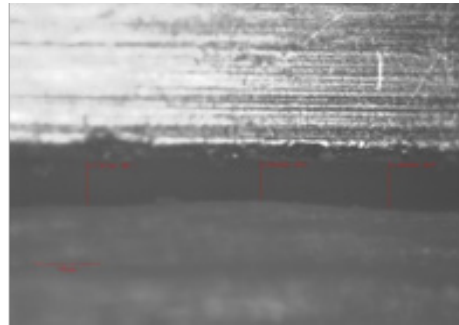
**Figure 3.** Confocal Microscopic analysis of Zirconia crowns to evaluate for the marginal integrity. (a) shows the evaluation of cement space under the confocal microscopy prior to cementation of the crown to the metal mold (b) shows evaluation of cement space under the confocal microscopy after the cementation of the crown to the metal mold. It was seen that there was minimum or no discrepancies in cement space both before and after cementation hence marginal integrity of the crown was maintained both before and after cementation.

A further advantage of a cervical collared design in bilayered crowns is that it provides for a simplified application of veneering material. Several authors have reported that the incidence of veneering material on the inside of the core is relatively common and this in turn may cause a discrepancy in the crown seating, thus affecting the marginal fit and compromising the stress distribution pattern which may be a cause of clinical failures. The presence of a cervical collar will help to reduce this possibility. This may also help in ensuring a smooth transition between the tooth, core and veneer material, thus facilitating biofilm removal [8]. An inadequate cement space has also been shown to affect the marginal fit of crowns. This variable was eliminated in the present study by providing for a uniform cement space of 30 microns for all the specimens and by further evaluation of fit of all the prepared crowns before and after cementation by confocal microscopy.

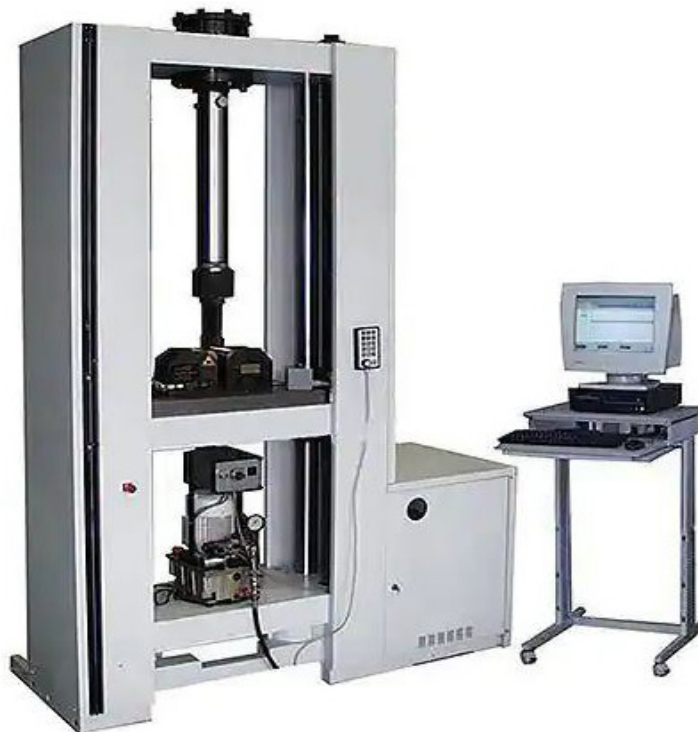
**Figure 4.** Samples placed in water assembly for Testing of flexure strength.

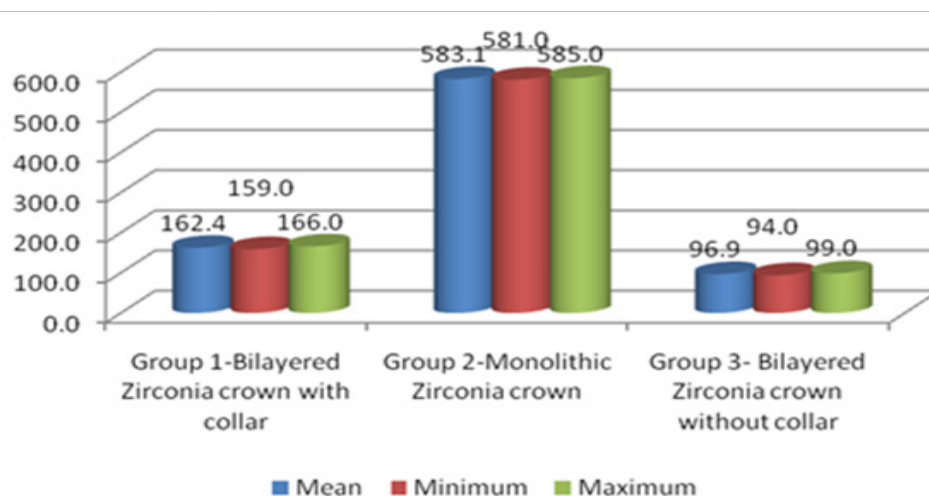
The mean values of amount of force required to fracture the zirconia crowns are shown in the graph. It shows that the maximum amount of force was required to fracture the monolithic zirconia crowns ( $583.1 \pm 1.2$ ) followed by the bilayered zirconia crown with the cervical collar ( $162.4 \pm 2.0$ ) followed by bilayered zirconia crown without cervical collar ( $96.9 \pm 1.3$ ).  $p$  – value  $\leq 0.05$  (Figure 5).

**Figure 5.** Mean values of the force ( Newtons).

The mean fracture loads value of the zirconia crowns were analyzed using one way ANOVA test which shows the significant difference among the mean fracture loads value of group 2 (monolithic zirconia crown)  $583.1 \pm 1.2$  is higher

than that of group 1 (bilayered zirconia crown with collar)  $162.4 \pm 2.0$  and group 2 (bilayered zirconia crown without collar)  $96.9 \pm 1.3$ .  $p$  – value  $\leq 0.05$  (Table I).
